**Flood Control Project Maintenance**  
**2009 Structure Summary Report**  
**Overall Unit and Item Ratings**

**Reclamation District No. 0999**

**Elk Slough Inlet Structure**

**Levee Inspection Report By Mile - Structure 2009**

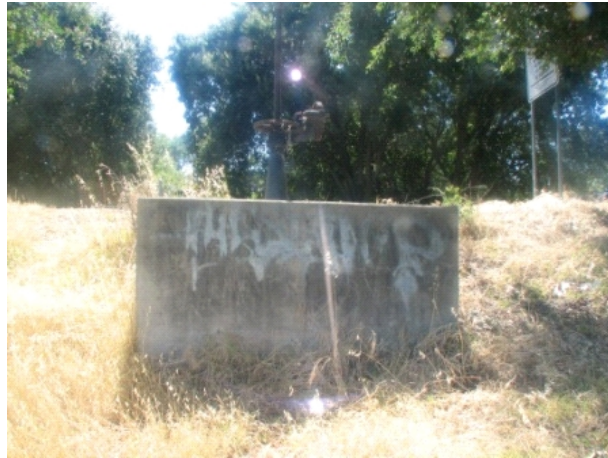
Levee Mile Report Line	1
Start Levee Mile	0.00
End Levee Mile	0.00
Location	Water Side
Category	Structures
Item	Photo Documentation
Looking (west) at front end of structure.	
richard_20091006_67.jpg

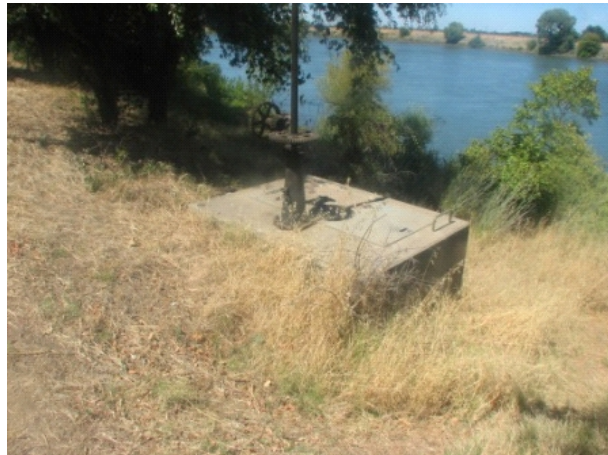
Levee Mile Report Line	1
Start Levee Mile	0.00
End Levee Mile	0.00
Location	Water Side
Category	Structures
Item	Photo Documentation
Looking upstream (north) at structure	
richard_20091006_69.jpg

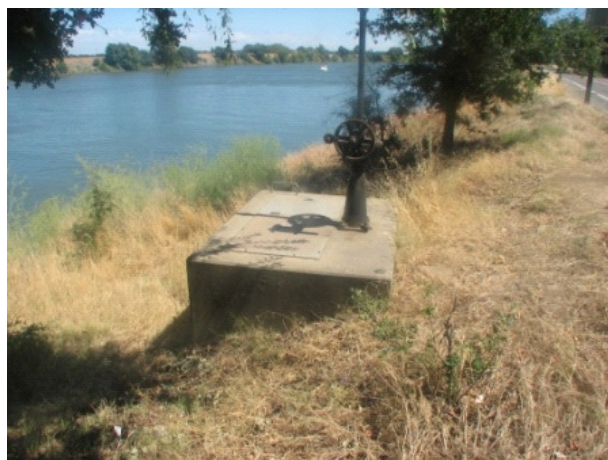
Levee Mile Report Line	1
Start Levee Mile	0.00
End Levee Mile	0.00
Location	Water Side
Category	Structures
Item	Photo Documentation
Looking downstream (south) at structure.	
richard_20091006_70.jpg

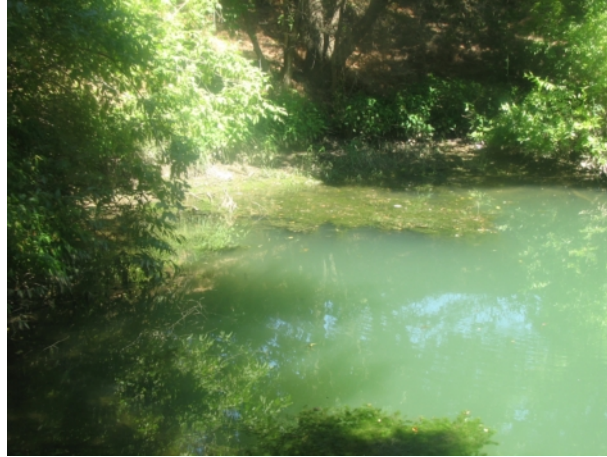
Levee Mile Report Line	1
Start Levee Mile	0.00
End Levee Mile	0.00
Location	Water Side
Category	Structures
Item	Photo Documentation
Looking (east) at inlet of structure pipe not invisible.	
richard_20091006_71.jpg
